## **Outstanding Projects for 2003**

## ***Paradise Creek TMDL Implementation Project***

### **Paradise Creek Urban Riparian Restoration**

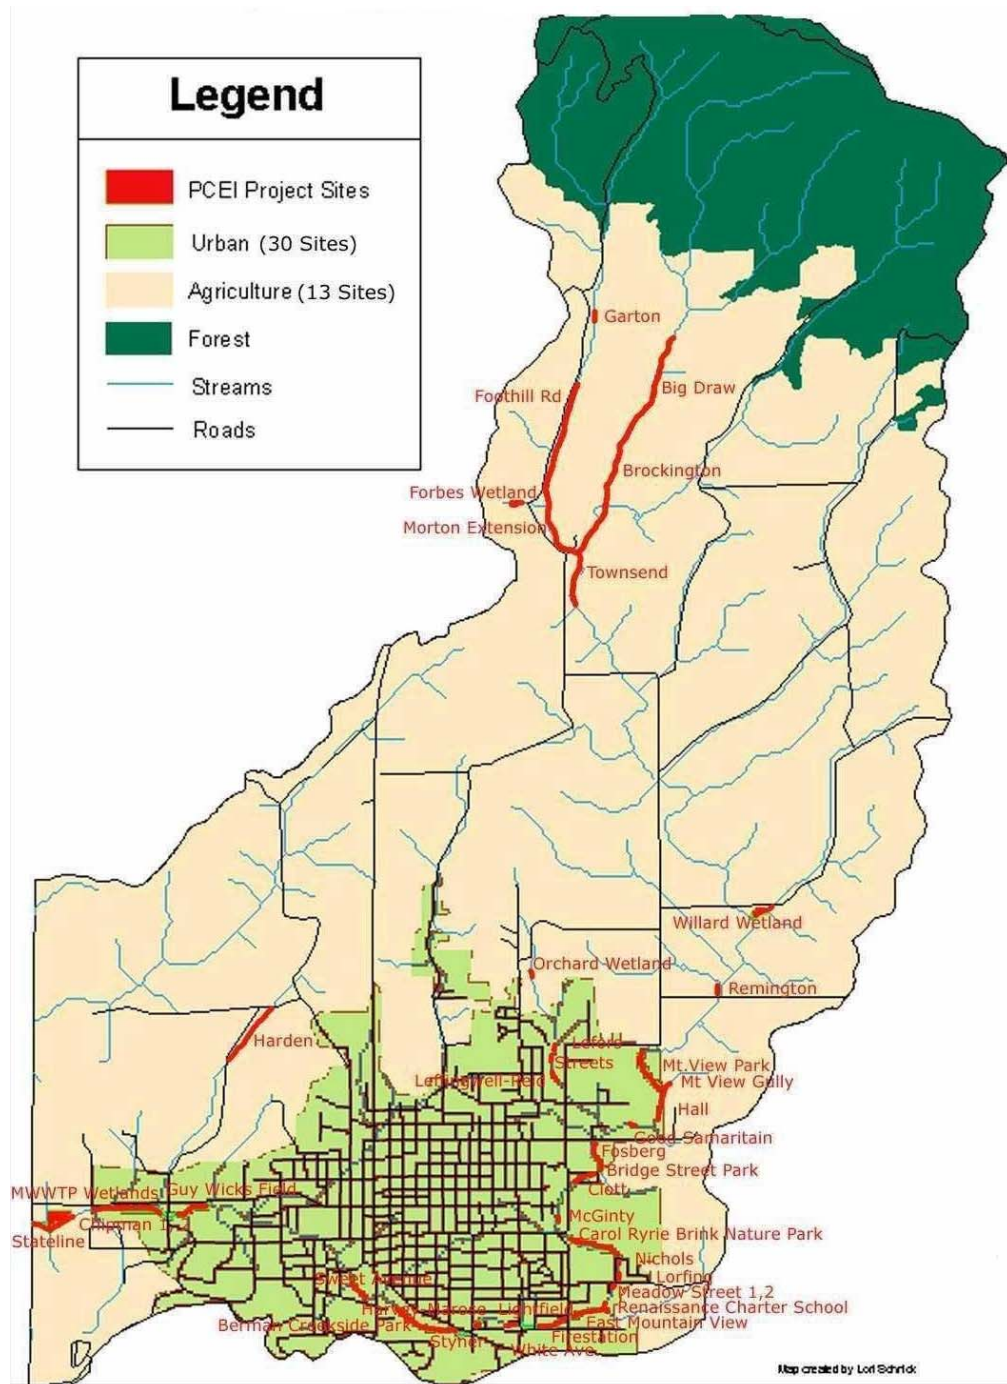
Figure 33: Paradise Creek Watershed Urban and Rural Projects, Moscow Idaho

All of these sub-projects are located on public or private land in the urban portion of the Paradise Creek watershed, within the City of Moscow (Figure 33).

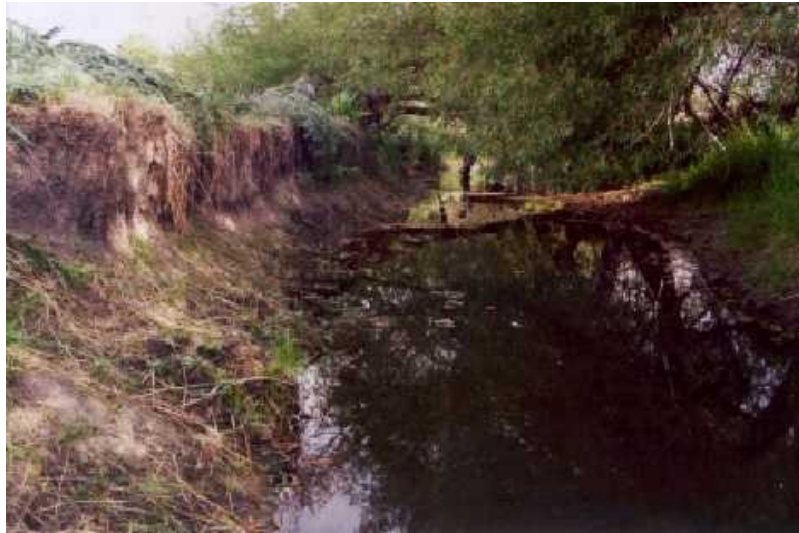
Figure 34: Berman Creekside Park Fall 2000

**Previous Conditions:** Much of the stream segment had nearly vertical, slumping, eroding stream banks that were frequently undercut by high water events, contributing to the sediment load in the creek. The majority of the stream bank soil was exposed, except for a few patches of reed canary grass. Where Paradise Creek flows through the park, it is lined by golden willows, a non-native willow species that discourages a diversity of riparian trees and shrubs and threatens power lines above. There were also areas of steep, eroding banks.

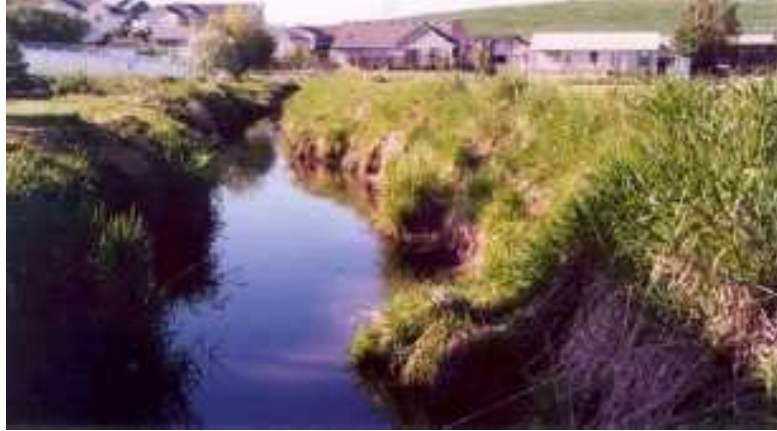
Figure 36: Bridge Street Park early Spring 2001

**Previous Conditions:** These stream segments had slumping, eroding banks that were frequently undercut during heavy storm events, contributing sediment to Paradise Creek (Figure 36). In addition, annual dredging artificially widened and incised the stream channel, causing raised water temperatures during low flow periods of the year. Reed canary grass was the dominant vegetation along this stream segment. Few trees or woody vegetation grew along the stream segment.

**Description of Completed Activity:** The purpose of the Bridge Street Park project was to reconfigure approximately 450 linear feet of a straight, ditch-like creek to a low-flow channel with a terraced floodplain. Approximately 390 cubic yards of soil were excavated from this site. The newly constructed low-flow channel has a 3 to 4 foot bottom width, much reduced from the prior width of 8 feet, and will convey 1.5 to 2 year flows (Figure 37). Approximately 195 cubic yards of the excavated soil were used as backfill to create the two-tiered floodplain, with soil wraps to increase the flood storage capacity of this reach. These geotextile fabric-wrapped soil “burritos” were stacked one upon the other, and seeded with native grasses. Each soil wrap is about 6 feet wide and one foot high. The floodplain was constructed to 20 feet wide on the west side of the stream in Bridge Street Park. The local 10-year flood elevation was decreased by a maximum of 0.2 feet. The 100-year flood elevation was decreased by 0.1 feet upstream of the project. In the fall of 2001, woody shrubs and trees were planted along the bank to shade the stream.

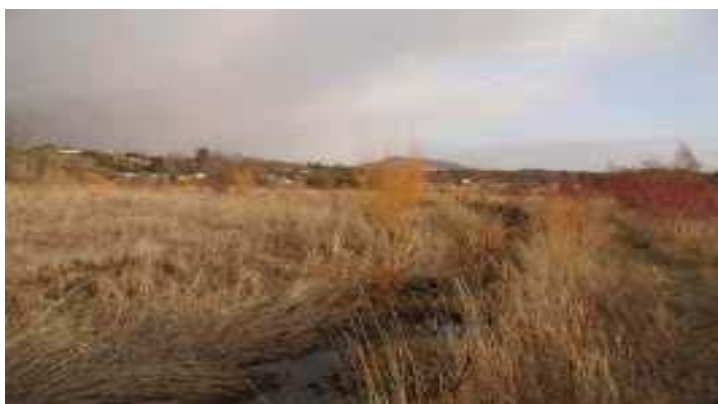
Figure 38: Carol Ryrie Brink Nature Park

**Previous Conditions:** Paradise Creek was straightened and channelized by former owners, creating unstable banks lacking riparian vegetation. The land adjacent to the stream was an active wheat field, and plant diversity along the stream channel was low. The creek was heated by direct solar radiation. The water quality was impaired by direct, un-buffered flows of storm water runoff. Wildlife habitat along the creek was minimal.

**Description of Completed Activity:** The floodplain and stream banks were restored through excavation, stabilization, and planting of native riparian species. In the fall of 1995, it took Roach Construction of Genesee, Idaho one week to excavate a 5-acre floodplain and re-meander 1,200 feet of stream channel. Excavation activities moved 12,000 cubic yards of earth. Volunteers, including Moscow schoolchildren, University of Idaho and Washington State University students, and community members, built three 175-foot revetments for stabilization and demonstration purposes, including a log-crib revetment, a BioLog® revetment, and a root-wad and rock revetment. PCEI volunteers seeded and mulched over 3,000 square feet of stream bank and 5 acres of floodplain, installed over 6,000 square feet of geotextiles, and planted over 750 native plants. In total, it took about 2,000 volunteer hours to construct this project. The site (Figure 38) was later christened the “Carol Ryrie Brink Nature Park,” named for the popular author who grew up in Moscow.

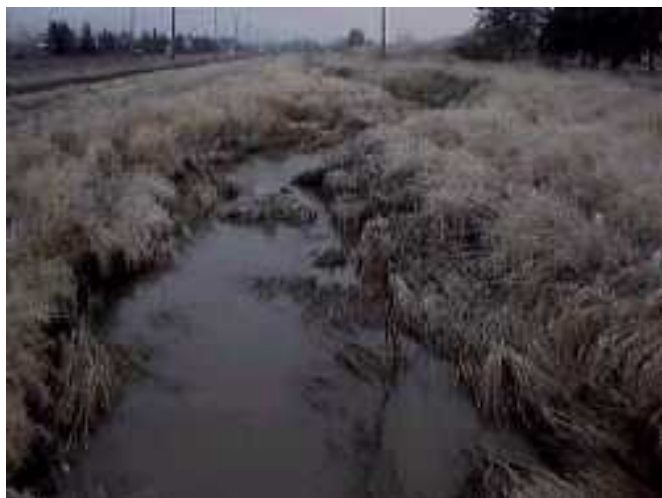
Figure 39: Chipman Trail Fall 1999

**Previous Conditions:** Weedy banks, devoid of woody vegetation, characterized this confined reach of Paradise Creek. The channel was dredged in the past and was wide, with steep, vertical banks. These conditions left the stream with eroding banks, high water temperatures, and minimal habitat value (Figure 39).

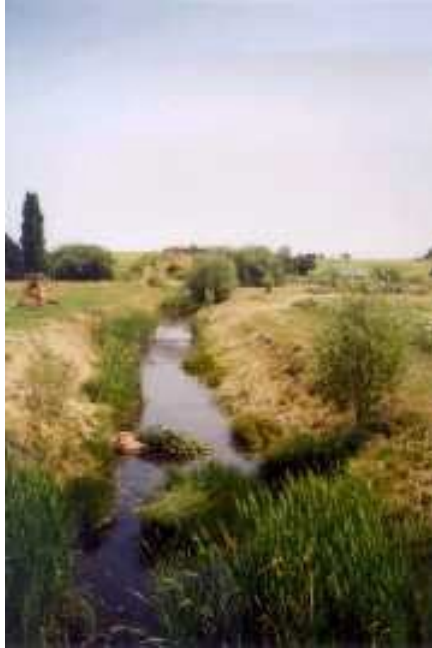
Figure 41: Before Spring 2000

**Previous Conditions:** This reach of Paradise Creek had a straightened, excessively wide channel with nearly vertical, eroding stream banks. The stream channel had been straightened, deepened, and widened by years of dredging (Figure 41). The steep banks were undercut during high flows, contributing to the sediment load in the creek. Reed canary grass was the dominant bank vegetation, and no native woody vegetation was present to control bank erosion or shade the stream.

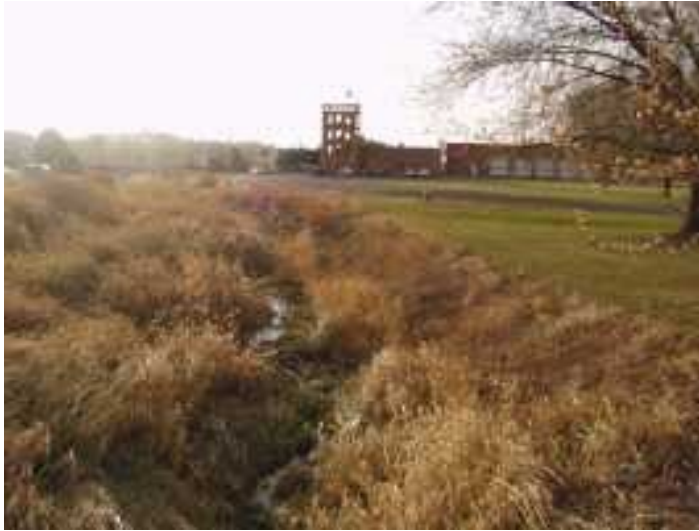
Figure 43: Fire Station Stream Bank Stabilization

**Previous Conditions:** The stream segment had nearly vertical, slumping, eroding stream banks contributing to the sediment load in the creek. There was also a lack of native woody vegetation close to the creek for shade. Paradise Creek had been dredged in this reach many times, which added to its degraded state.

**Description of Completed Activity:** This project stabilized a highly impacted area of the stream bank and added a riparian buffer. Due to the confined nature of the stream at this point, and the close proximity to the Moscow Fire Station, a small area of rip-rap was placed in conjunction with coconut fiber Biologs® along the upstream portion of the project. Erosion control fabric was installed on the remaining portion of the stream bank. The Biologs® were planted with native herbaceous plugs. All exposed stream banks were seeded with native grasses, and woody shrubs were planted on the banks and at the top of the stream bank (Figure 43).

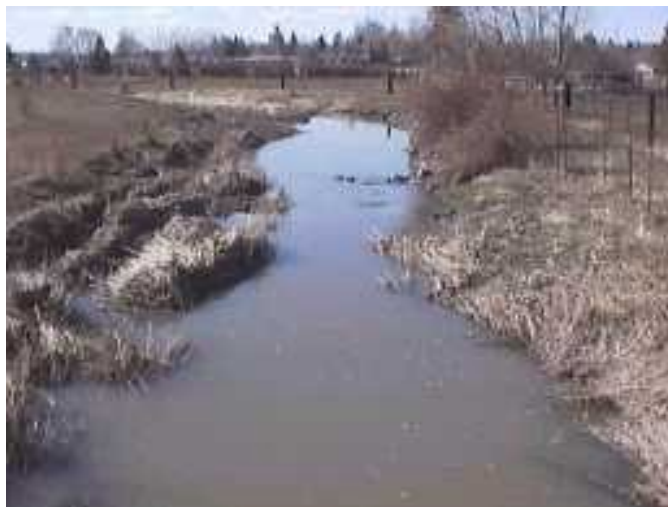
Figure 44: Fosberg area prior to planting

**Previous Conditions:** This site was previously used as pasture and the landowners decided to retire the land from grazing, so the property was entered into a land easement with the Palouse Land Trust. The riparian area was dominated by a monoculture of reed canary grass, which provides little shade, sediment retention, or wildlife habitat (Figure 44).

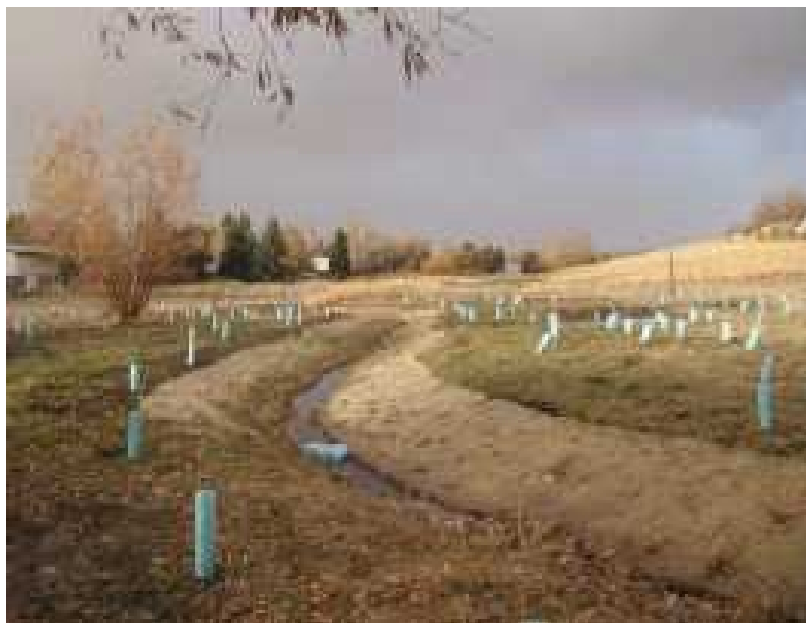
Figure 46: Leffingwell-Reid property after work was complete in Fall 2003

**Previous Conditions:** Prior to restoration, this Paradise Creek tributary was a straight, incised channel. Reed canary grass was the predominant species, with a vigorous infestation of Canada thistle and morning glory. The site had few native trees and shrubs, grasses and forbs. The stream reach was exposed to direct solar radiation as well as storm water runoff containing sediments, nutrients, and pesticides.

Community volunteers helped seed the site with native grasses and install geotextile fabric on newly constructed banks. Wetland transplants and herbaceous plugs were planted along the stream channel, as well as in and around the three wetlands. Stream banks and wetland edges were seeded with native grasses, including tufted hairgrass, ticklegrass, fowl bluegrass, western managrass, prairie junegrass, and Idaho fescue. The riparian area was also planted with herbaceous species (small-fruited bulrush, common rush, creeping spikerush) and native woody species (red osier dogwood, sandbar and Mackenzie willow [plugs], quaking aspen, Douglas hawthorn, Nootka rose, serviceberry, shiny leaf spirea, and syringa).

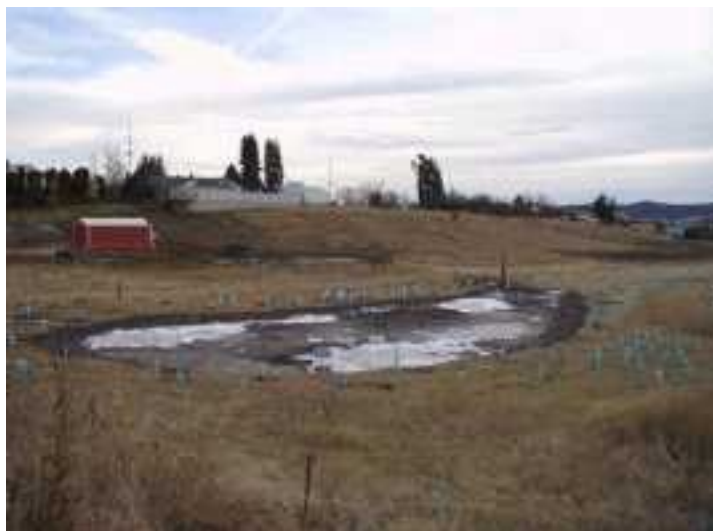
Figure 47: Construction of Lefors Wetland

**Previous Conditions:** The site is located along a tributary to Paradise Creek north of the Streets Wetland site. A horse barn on the east side and a wide, flat wet area to the west bordered the stream segment. The site is inundated with water for a significant portion of the year, and this condition made the site suitable for wetland construction. Reed canary

After excavation, native woody shrubs, trees, and grasses were planted along the bank and around the wetlands. Herbaceous wetland plants were planted in the wetland to help improve water quality by reducing nutrient loading through filtering. Native willow species and red-osier dogwood cuttings were planted along the banks of the stream to secure the banks and introduce shade to the system.

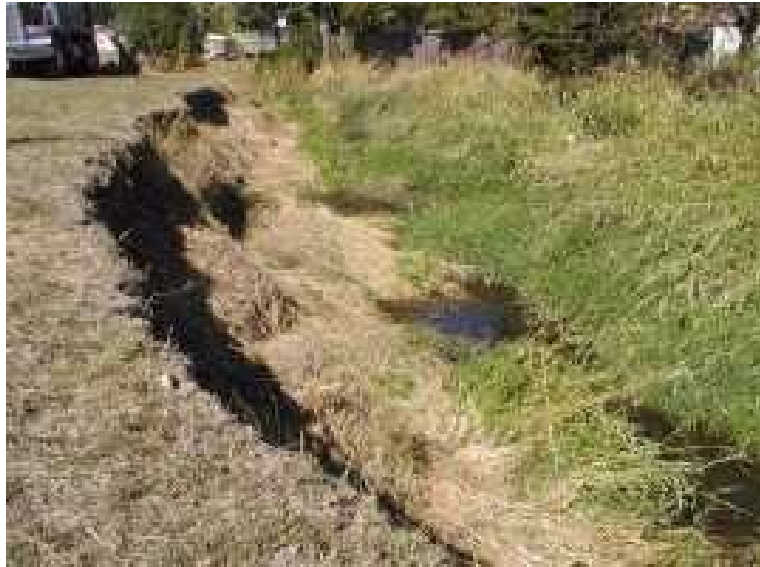
Figure 48: Lightfield Stream bank before work

**Previous Conditions:** The stream segment had nearly vertical, slumping, eroding stream banks that contribute to the sediment load in the creek. Reed canary grass was the predominant species on this stream reach. There was a lack of existing native woody vegetation close to the creek to help shade out weeds and decrease water temperature. In

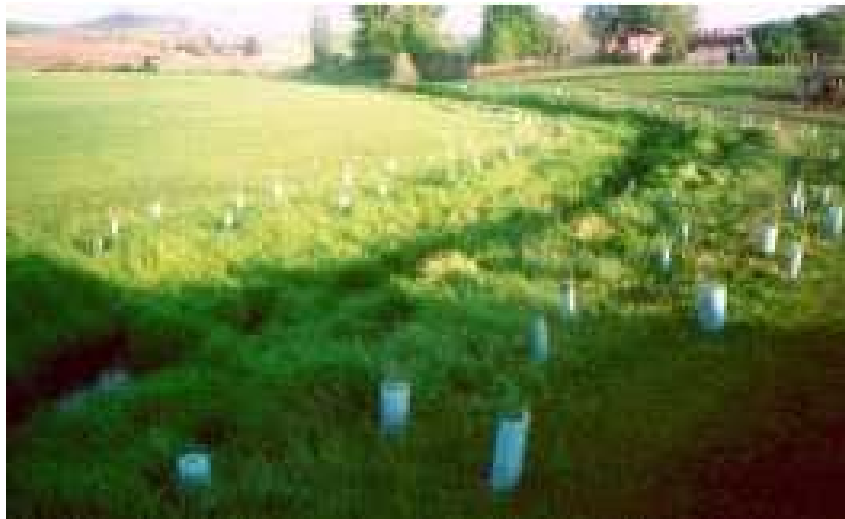
Figure 50: Mountain View Park plantings

**Previous Conditions:** This section of stream was dominated by a monoculture of reed canary grass, with no native woody vegetation. Most of the banks had a moderate slope, but portions were eroding into the creek due to the absence of vegetation. The lack of riparian cover increased water temperatures in the unshaded stream. Storm water runoff from adjacent parking lots and playing fields flowed directly into the stream.

**Description of Completed Activity:** Beginning in 1999, a variety of volunteer groups helped plant 1,100 trees and shrubs along the tops of the stream banks. In spring 2000, 600 plants were planted and in the fall an additional 500 plants were planted at this site. All plantings have protective tubes installed around them (Figure 50). These plantings will eventually create a riparian forest buffer along the creek, shading the stream, filtering runoff, and enhancing wildlife habitat and aesthetics. In 2001, PCEI staff and volunteers replanted vegetation in areas of low survival and performed maintenance of previous plantings, including weeding, tube removal and watering. The Mountain View Park site was also the headquarters of the Annual Paradise Creek Clean-Up.

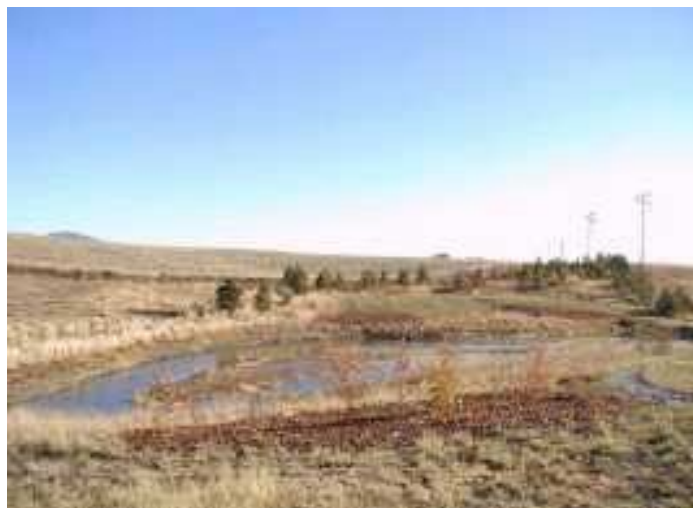
Figure 51: Orchard Wetland

**Previous Conditions:** This site is located in a low-lying area, containing few trees or woody vegetation, that feeds a tributary to Paradise Creek.

The site is inundated with water for a significant portion of the year, and this condition made the site suitable for wetland construction. Reed canary grass was the dominant vegetation along the stream segment, and few trees or woody vegetation were present. A horse pasture upstream of the site contributed associated pollutants to the stream.

wetland area was planted with woody vegetation as well as wetland vegetation to help improve water quality by reducing nutrients through the water-filtering qualities of wetland plants. The banks of the wetland area were secured with geotextile fabric and were seeded with native grasses. In the spring of 2002, willow poles and red osier dogwoods were planted along the banks to secure the banks and introduce shade to the system. Additional native plantings were planted in the spring of 2002 (Figure 51).

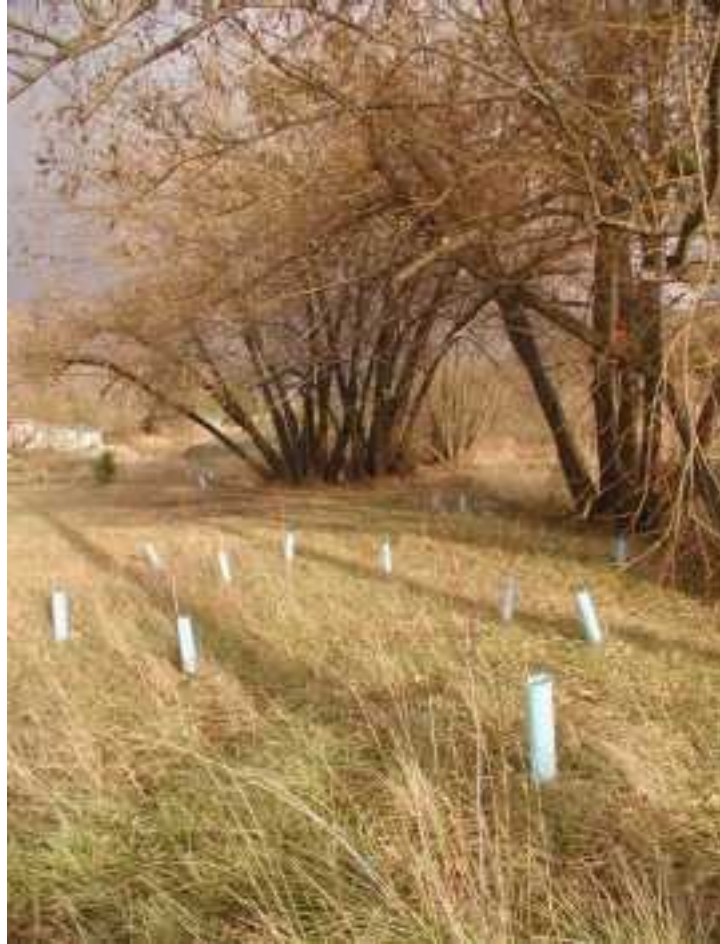
Figure 52: Renaissance Charter School riparian planting

**Previous Conditions:** The stream segment had nearly vertical, slumping, eroding stream banks that were frequently undercut by high water events, contributing sediment to the creek. The majority of the stream bank soil was exposed, except for a few patches of reed canary grass. Where Paradise Creek flowed by the school, it was lined by golden willows, a non-native willow species that discourages a diversity of riparian trees and shrubs and threatens power lines above.

**Description of Completed Activity:** Willow poles and other native riparian plant species were planted along the stream banks and on the floodplain (Figure 52). These native shrubs will help stabilize the failing stream banks, shade the stream, and introduce woody material to the stream system. Charter school students helped with the planting, and ongoing plant maintenance. In addition, students worked with PCEI staff to install log habitat structures.

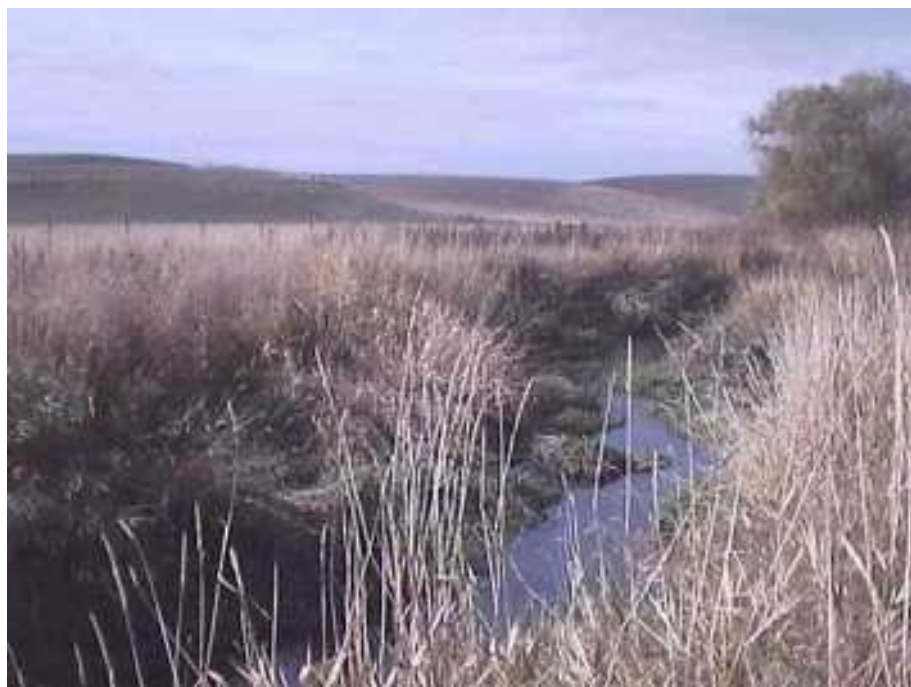
Figure 53: State Line stream bank stabilization and riparian Planting

**Previous Conditions:** Stream banks along this segment of Paradise Creek were eroding due to a lack of woody vegetation and the steepness of the banks. Reed canary grass formed a dense monoculture whose shallow root mats promoted slumping of the stream bank. Thus, the stream banks were frequently undercut during heavy storm events. Moreover, the lack of trees or woody vegetation along this stream segment also allowed solar radiation to heat the stream water, which decreases dissolved oxygen and is damaging to aquatic wildlife.

Willow (*Salix exigua*, *Salix Drummondia*, *Salix mackenziana*) and red-osier dogwood (*Cornus stolonifera*) poles and dogwood fascines were planted on the stream banks where the initial vegetation did not establish well. Through time, the poles will provide a dense network of interconnected roots to hold the bank in place and catch sediment and organic matter to facilitate the establishment of other vegetation (Figure 53).

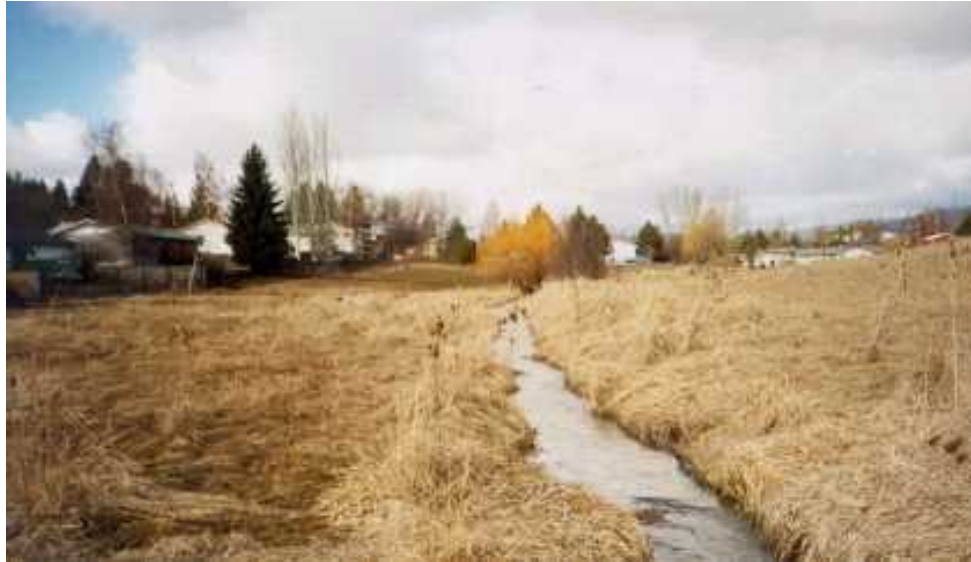
Figure 54: Streets site before planting

**Previous Conditions:** The site is on a tributary to Paradise Creek in a draw. The stream segment was bordered by a steep bank on the east side and a wide, flat wet area to the west. The site was inundated for a significant portion of the year, which made it a suitable location for a wetland. Reed canary grass was the dominant vegetation along the stream segment, and few trees or other woody species were present. The site was directly downstream from a horse pasture and was impacted by associated pollutants entering the water from upstream.

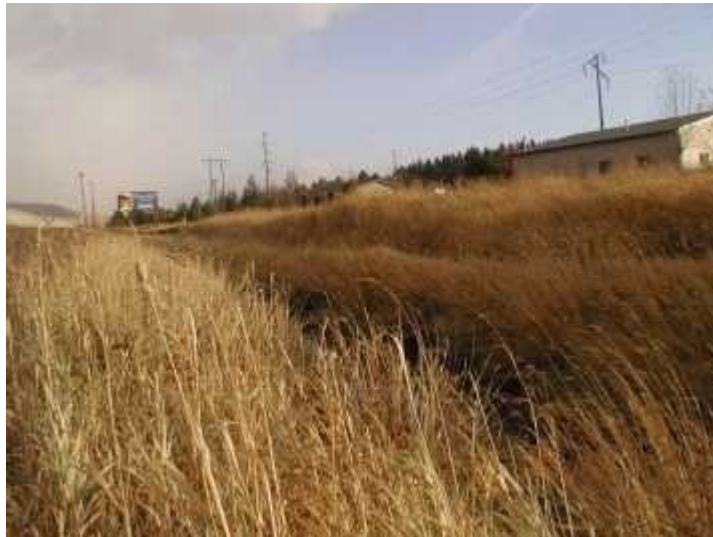
Figure 56: Styner riparian area before planting

**Previous Conditions:** This stream reach had been routinely dredged by the City of Moscow, and the dredge spoils had been dumped on the stream bank. Consequently, the stream channel is excessively wide and uniform, with steep, very high banks. Reed canary grass, Canada thistle, and prickly lettuce were the only vegetation on the stream banks.

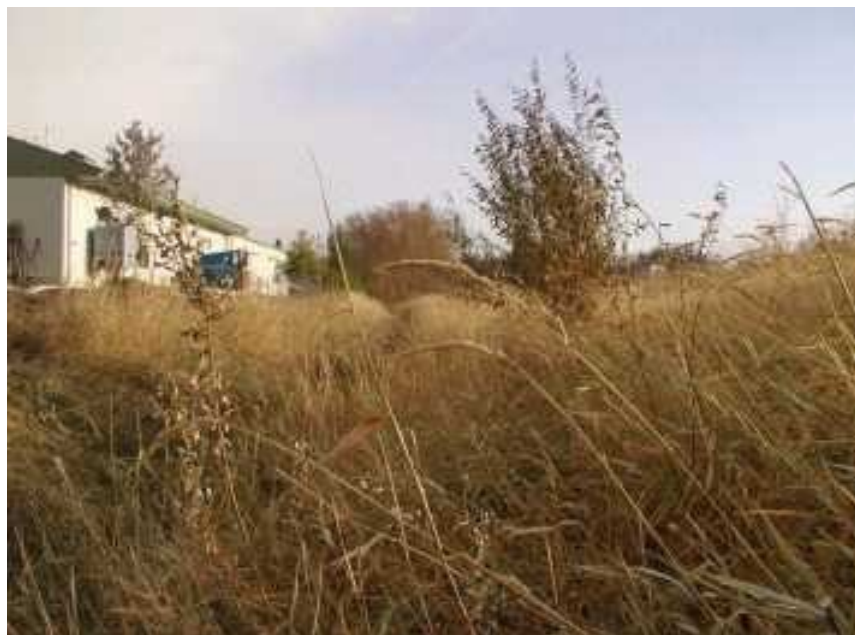
Figure 58: Sweet Avenue riparian planting

**Previous Conditions:** This section of Paradise Creek had been channelized and straightened. Eroding banks rose steeply on both sides. Lack of vegetative cover allowed solar radiation to warm the stream. These conditions presented minimal habitat value for wildlife. Furthermore, a parking lot was scheduled for construction adjacent to the stream, and this restoration project provided opportunities to create bio-filtration systems for the future parking lot runoff. The floodplain had been occupied by a concrete batch plant and by a pesticide and diesel storage facility. Hazardous waste cleanup was conducted by the State of Idaho.

**Description of Completed Activity:** PCEI constructed channel meanders, a narrower low-flow channel, and a more functional floodplain. The meanders provide increased surface area for infiltration and reduced water velocity, and the constructed low-flow channel, sized for 2-year flows, benefits the aquatic biota. (The riparian floodplain was built to contain a 500-year event and provide water storage during storm events.)

Water quality is improved as suspended sediment and associated pollutants settle out on the floodplain during flood events. Hydrologic modeling showed that the constructed two-stage flood channel would not cause a rise in 100-year flood elevations. In fact, the modeling showed a drop in localized flood elevations of up to 1.5 feet.

This project included a baseline- and effectiveness-monitoring component that documented biological, chemical, and physical components of Paradise Creek at the Sweet Avenue reach and other sites within the City of Moscow for comparison. Bioaccumulation data was also collected, which may provide valuable information for restoring coldwater biota and salmonids in the Paradise Creek Watershed (Figure 58).

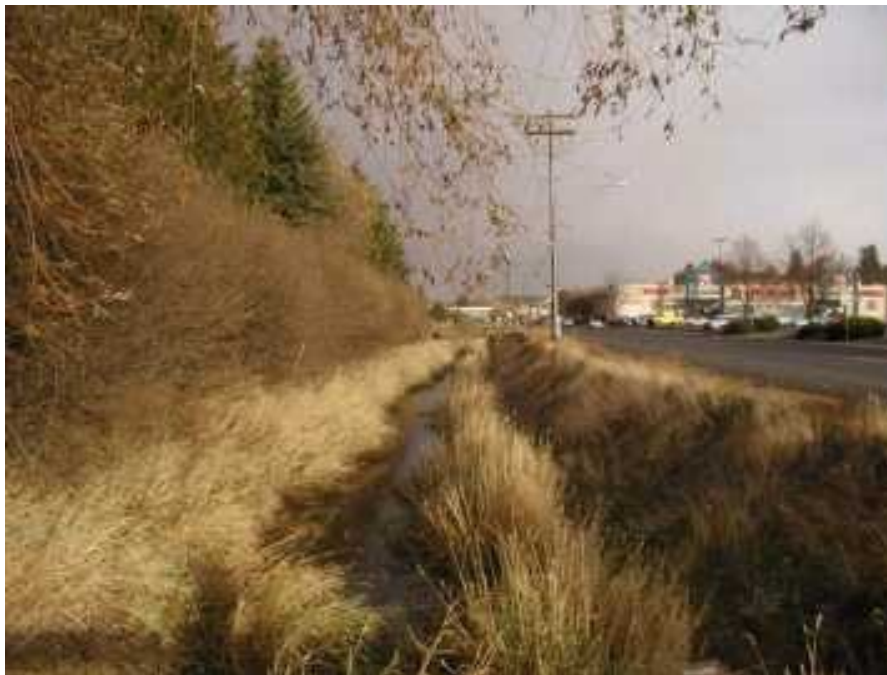
Figure 59: Moscow wastewater treatment wetlands planting

**Previous Conditions:** The stream segment had near vertical, slumping, eroding stream banks with little vegetation that contributed to the sediment load in the creek. Paradise Creek had been dredged in this reach many different times, which added to its degraded state. In the past, the City of Moscow dumped asphalt onto the sides of the bank in an effort to stabilize the side.

**Description of Completed Activity:** The purpose of this project was to reslope the stream bank to a 2:1 or 3:1 slope from its near-vertical state reduce erosion, and allow for the establishment of woody vegetation. The project site is 358 linear feet of a heavily damaged, ditch-like creek. The stream bank is composed almost entirely of fill, especially gravel and concrete chunks. After removal of the debris, the site was hydroseeded with a native seed mix and then covered with erosion control fabric. Snowberry and Wood's rose were planted on the site. A few sedges and rushes were planted at the toe of the slope (Figure 59).

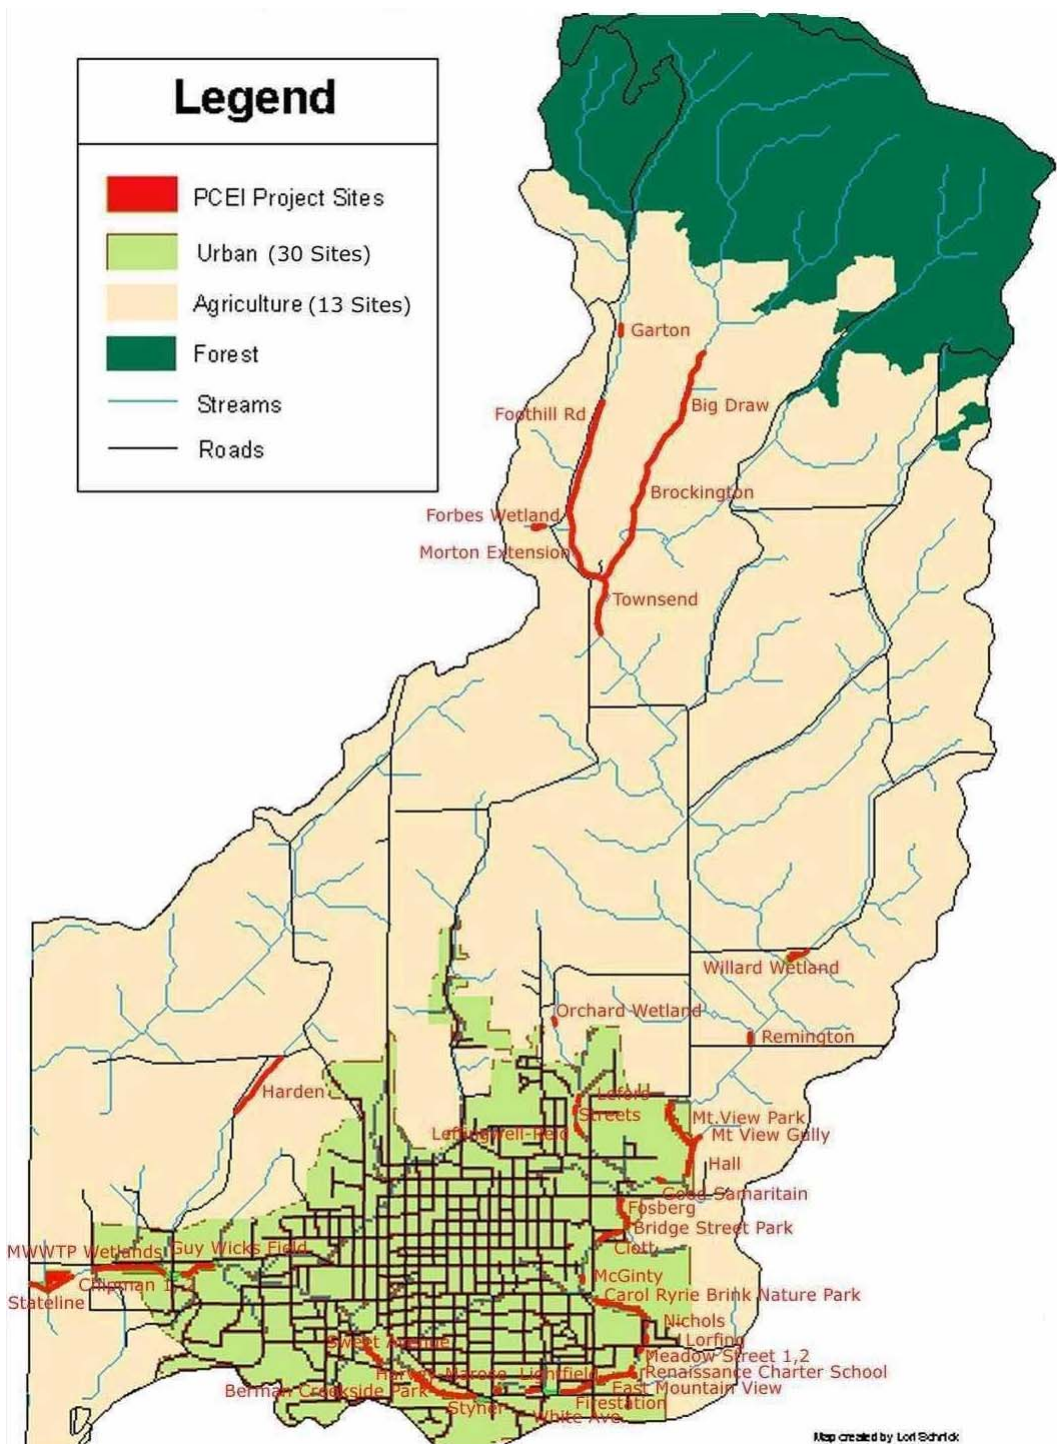
Figure 60: Paradise Creek Watershed Urban and Rural Projects, Moscow Idaho

All of these sub-projects are located in the rural Paradise Creek watershed upstream of the City of Moscow (Figure 60). All of the sub-projects were funded through the NPS 319 grant. Partners and local matching funds came from a wide variety of sources.

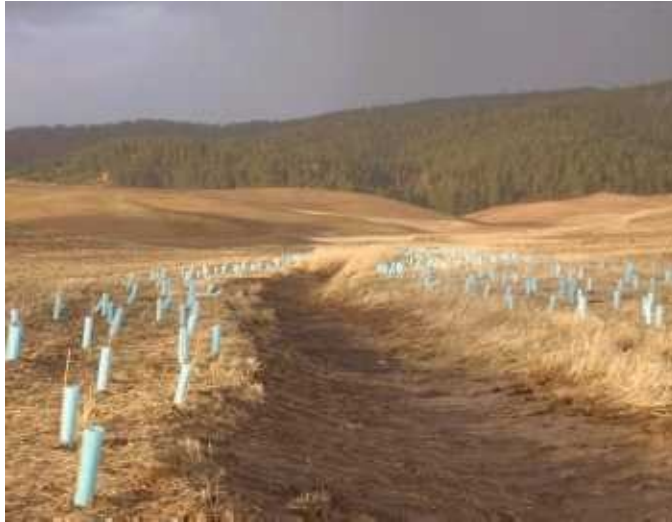
Figure 62: Brockington Riparian Area immediately after woody vegetation was planted. Farm equipment will be restricted to designated waterway crossings. Plastic collars protect young plants from deer and elk until plants become established.

**Description of Completed Activity:** The scope of this project was to plant a variable width buffer along the two tributaries on this property, including a total length of 2,500 feet. The riparian buffer ranges from 10 to 40 feet in width and consists of native shrubs and trees. The buffer area of the eastern tributary was also seeded with native grass seed. PCEI completed minimal excavation along the eastern tributary to create a narrow, low flow channel with associated floodplain, in conjunction with the adjacent Townsend project. In addition to the excavation coordinated by PCEI (the current agricultural operator), Larry McMillan contributed by excavating the sediment-laden channels of both tributaries. McMillan's work included excavating to the level of the culvert below the Brockington driveway. The Brockington project borders the Big Draw project to the north and the Townsend project to the east and south, therefore it is expected to have significant benefit as a wildlife corridor as vegetation matures (Figure 61 and Figure 62).

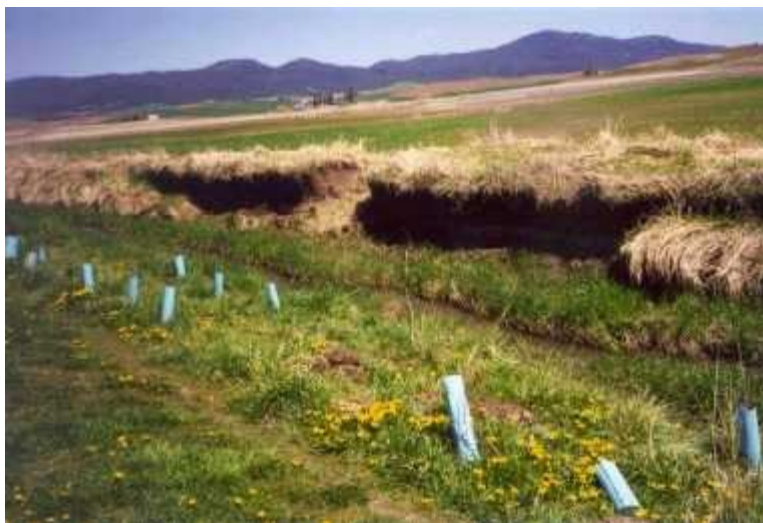
Figure 67: Hall and Mountain View Gully before work

Figure 67 shows the near vertical bank cut before the work was completed and Figure 68 shows the bank after work was completed.

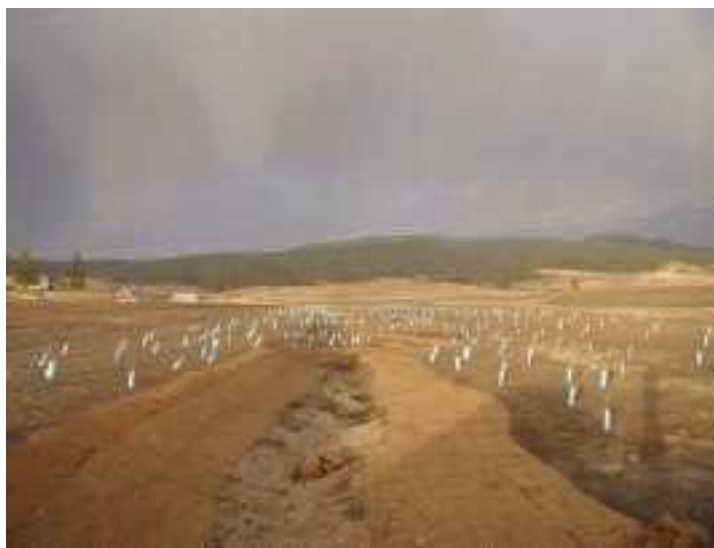
Figure 76: Within one year Townsend waterway will have stable banks and support sustainable, healthy riparian vegetation.

**Description of Completed Activity:** The scope of work included excavating the floodplain, defining a narrow, low flow channel and planting a riparian buffer of woody and herbaceous species. Excavation occurred in September 2003. Excavation was done in two phases. The downstream end, below the confluence of two tributaries was completed first and excavation of the eastern-most tributary was second. The channel was constructed using an excavator and excess soil was spread outside the floodplain on the Townsend property using a bulldozer. A multi-level floodplain was constructed to accommodate varying flow levels. Meanders were constructed in the new stream channel. A two layered soil wrap revetment was constructed on the downstream end of the project to protect against further erosion of a previously existing scour pool. After construction, all exposed soil was seeded with native grasses and banks were covered with erosion control fabric. In October and November 2003, a riparian buffer of native trees and shrub, varying in width from 45 to 90 feet, was planted on either side of the stream (Figure 75 and Figure 76).

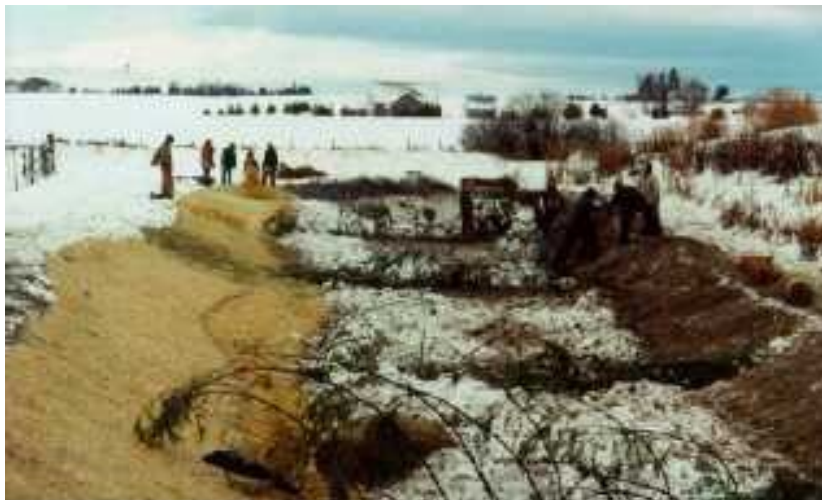
Figure 77: Biologs® stabilize stream bank

**Description of Completed Activity:** The main purpose of this project was to create a sediment catchment system to trap sediment-filled high water. Another goal was to stabilize and revegetate a 300-foot section of the tributary to provide habitat for wildlife, provide shade to reduce stream temperatures, provide a vegetated buffer from agricultural runoff, and reduce the amounts of sediments entering the stream. Earth moving was completed by Professional Operators Company. PCEI staff and volunteers completed the bank stabilization activities. The catchment banks were sloped to a 3:1 slope. This moderate slope reduces erosion, reconnects the stream to its floodplain, and creates a prime area for native vegetation. The resloped banks were seeded with a riparian grass mixture and covered with geotextile fabric. Native woody vegetation was planted in the spring of 2002. All excavated material was removed off-site. In selected areas (Figure 77), coconut fiber-filled BioLogs®, pre-planted with wetland plants, were installed along the toe of the stream bank for stabilization and to improve water quality through the water-filtering qualities of wetland plants. Woody debris of cedar and pine were installed in the catchment to act as a filter and, in turn, to slow the velocity of the water so sediment could settle out. Planting of native woody and herbaceous vegetation was completed in the spring of 2002 by PCEI staff and volunteers.
